2021-01-25

ST MARY THE VIRGIN ANGLICAN CHURCH CONDITION ASSESSMENT & PROJECT PLANNING

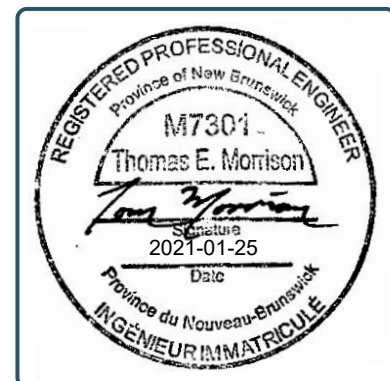
301-346 Queen St, Fredericton, NB

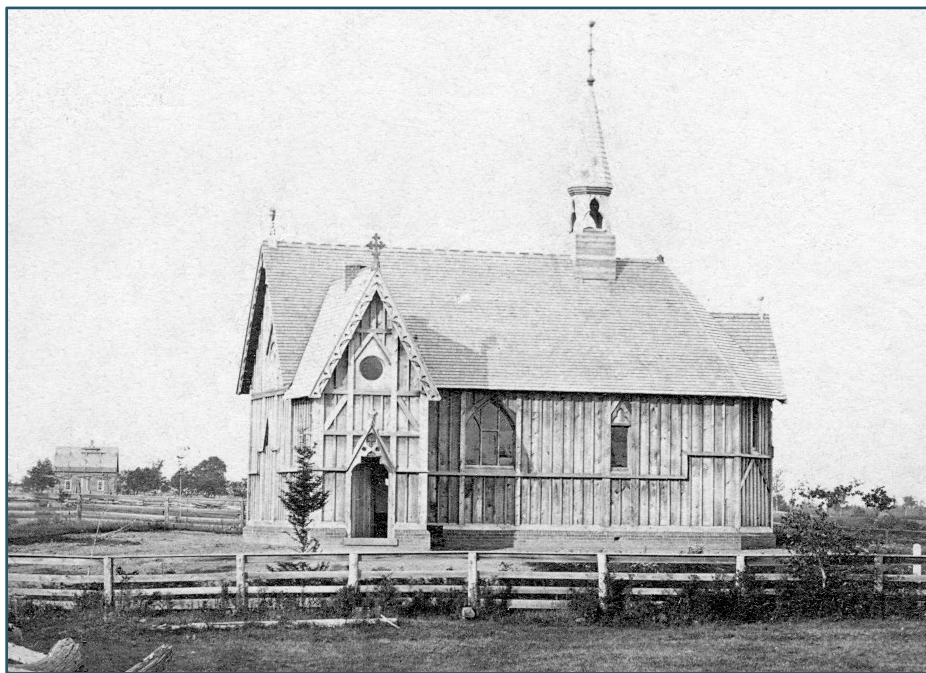
Figure 1: St Mary the Virgin Anglican Church, circa 1865

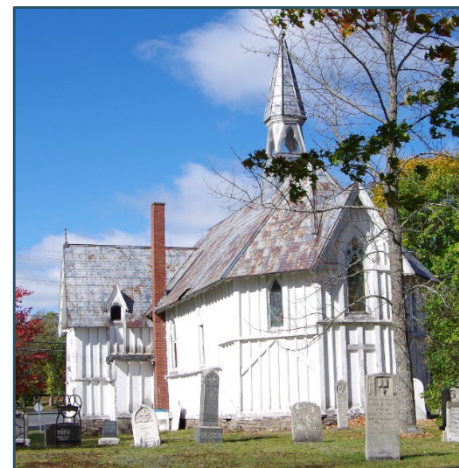
Figure 3: East gable, showing stained glass, cross motif, and trefoiled bell tower

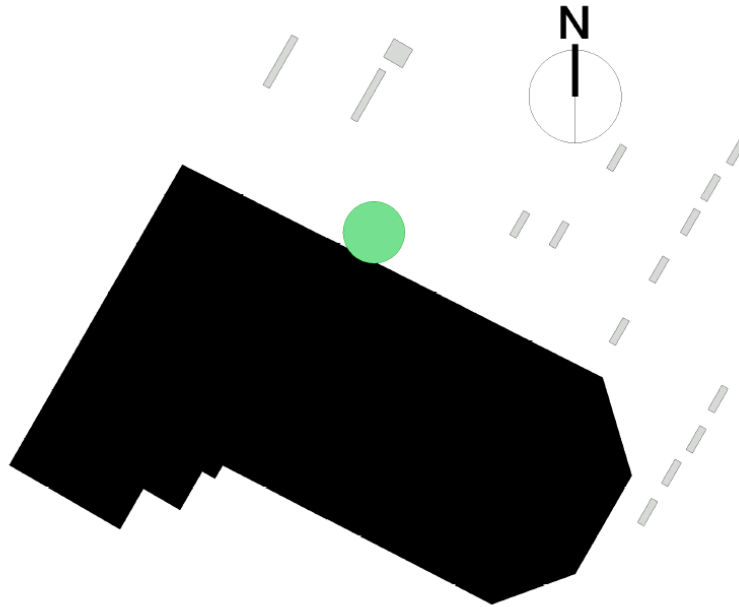
Figure 4: Site plan showing gravestones (grey) and shrub (green)

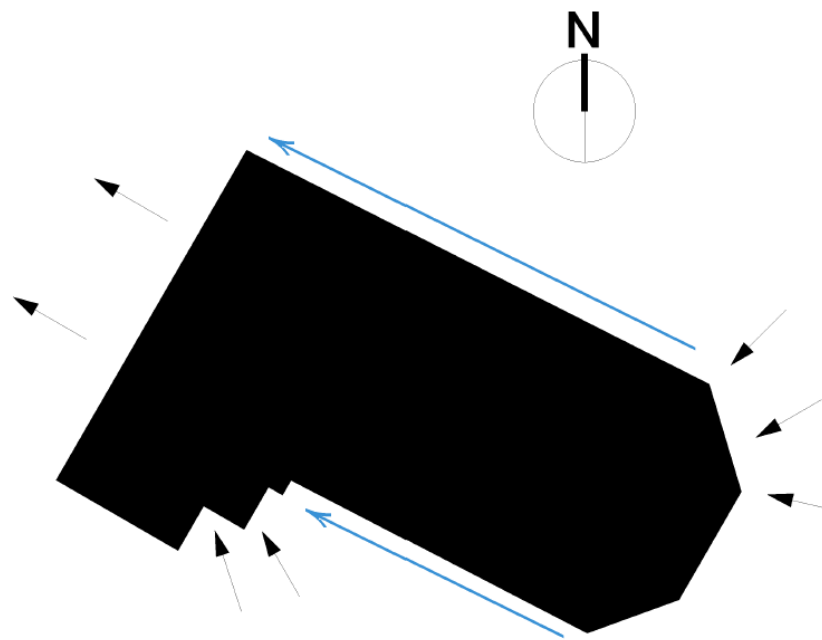
Figure 5: Drainage plan with ditches shown in blue, arrows show direction of ground slope

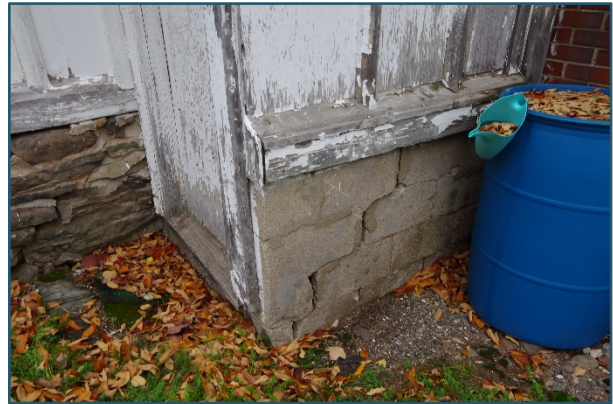
Figure 7: Moisture draining towards foundation near shed

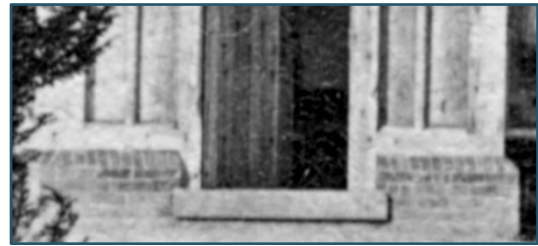
Figure 8: Brick foundation, circa 1865

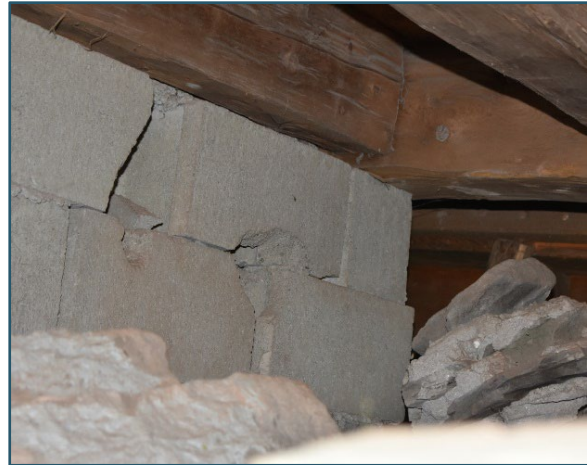
Figure 9: Damaged concrete block wall

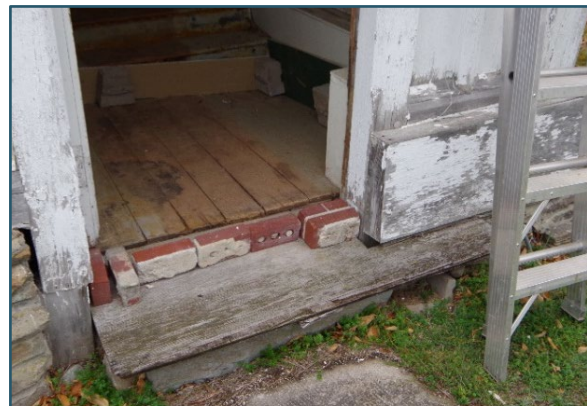
Figure 10: Stone door sill, removed

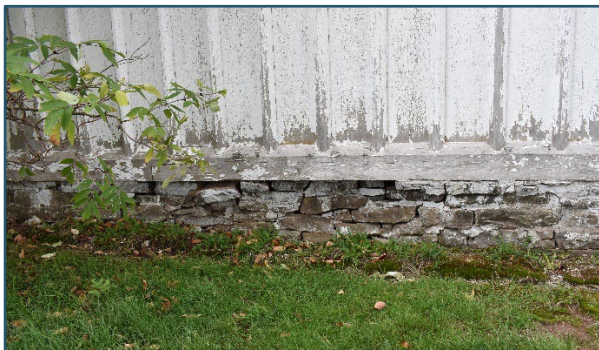
Figure 11: North wall partial collapse west of large window

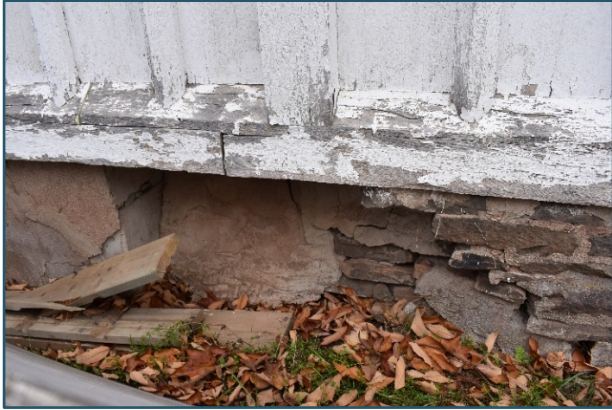
Figure 15: Parging failure and collapse at block wall near chimney

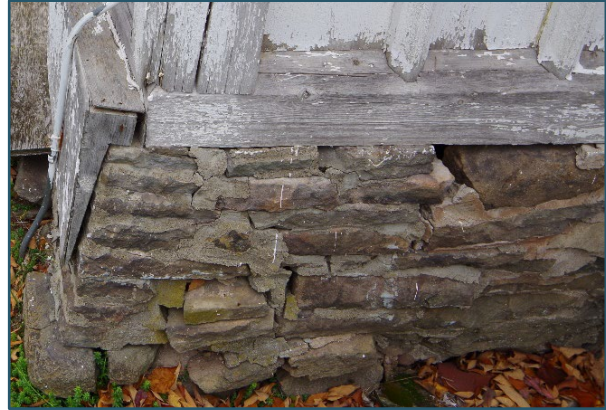
Figure 16: Diagonal cracking and inappropriate plywood repair at southeast narthex corner

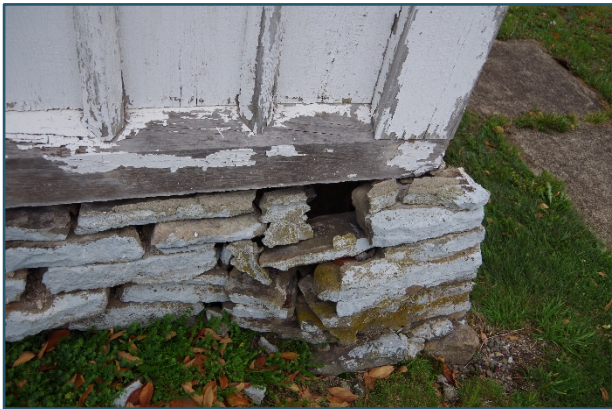
Figure 17: Collapse and cracking at southwest corner

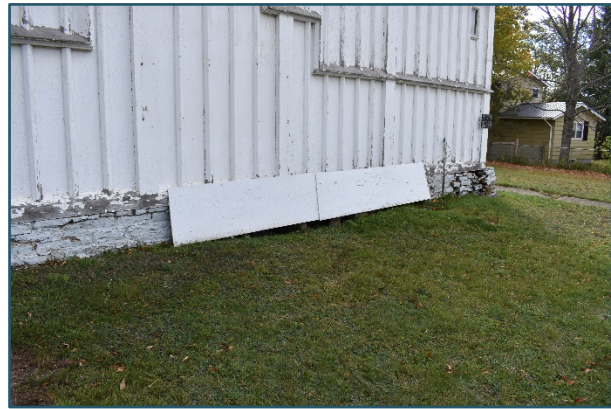
Figure 18: Boarded up collapsed west foundation

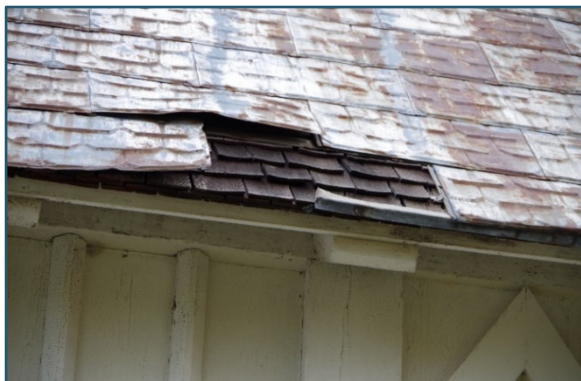
Figure 19: Original wood shingles under newer metal roof

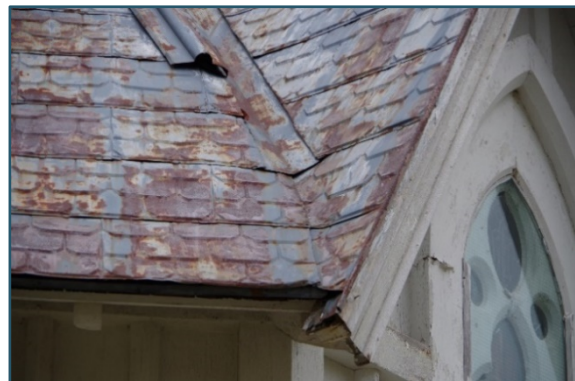
Figure 20: Missing flashing at roof valley

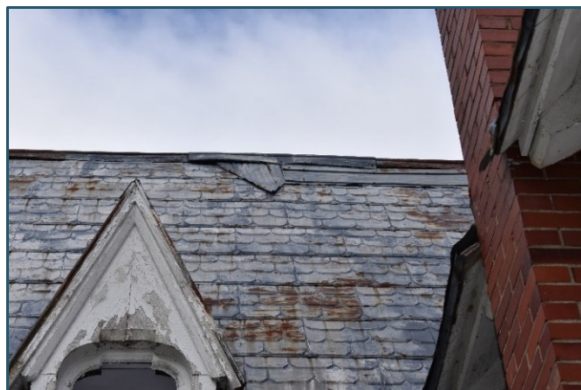
Figure 21: Patched roof at previous chimney location

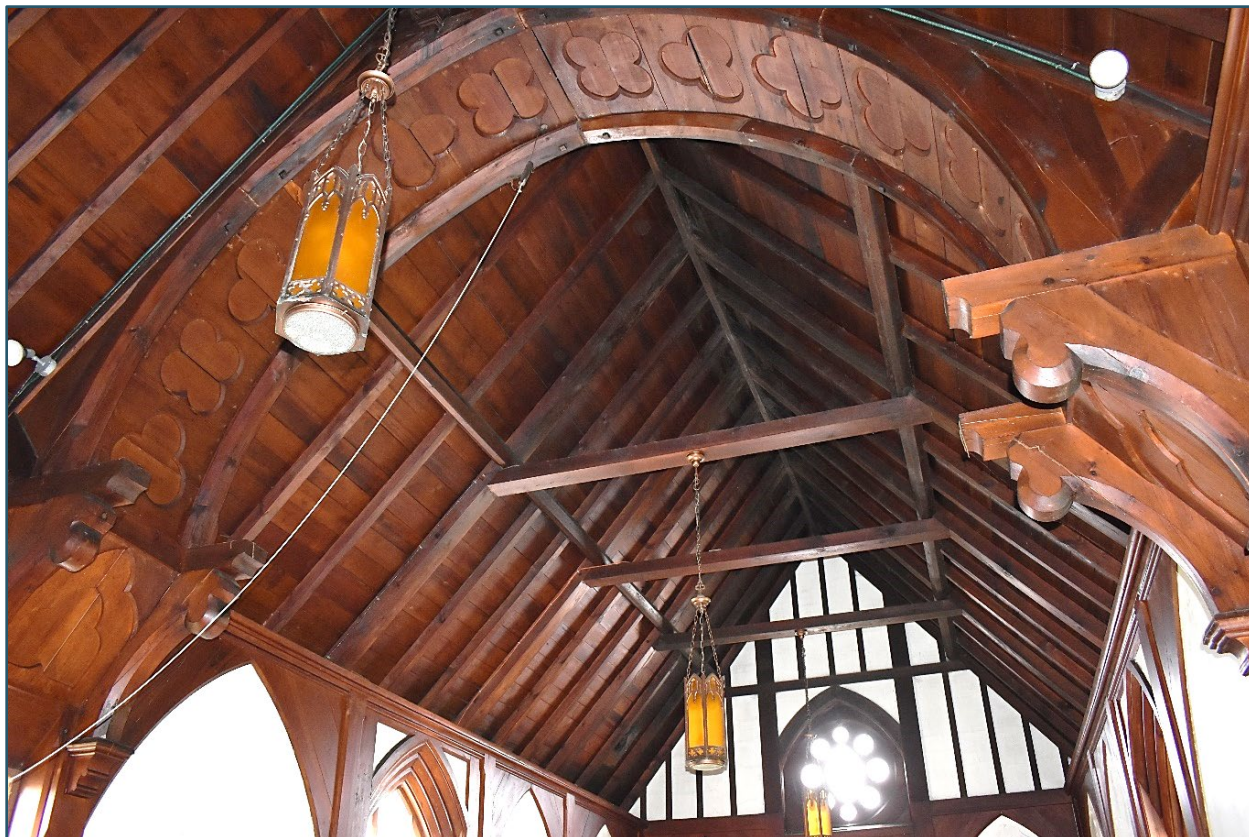
Figure 23: St. Mary the Virgin Catholic Church interior roof structure

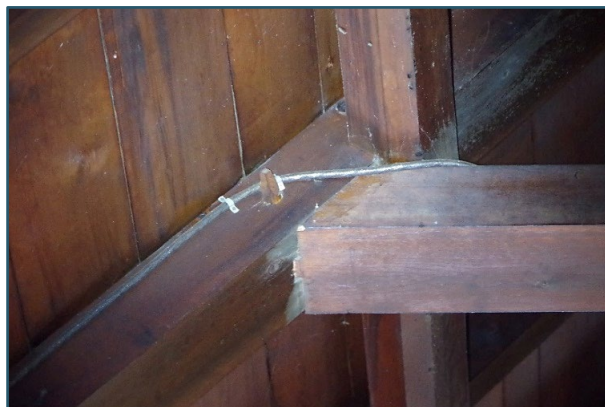
Figure 22: Pegged mortice and tenon joint between rafter and tie beam

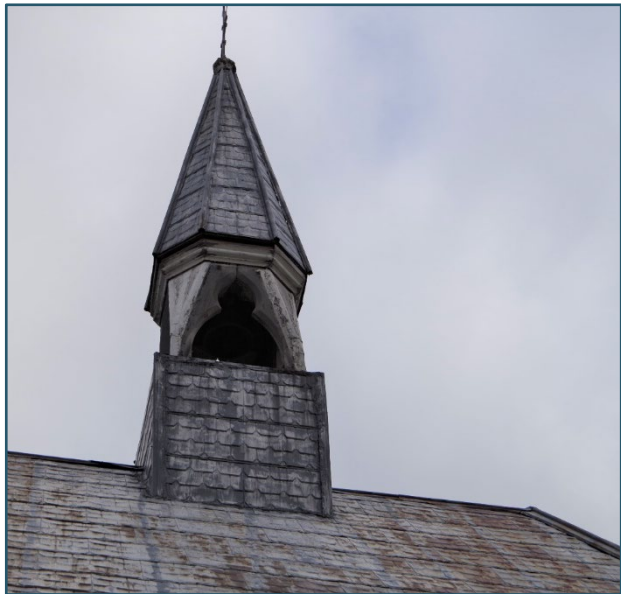
Figure 24: Bell tower viewed from ground level

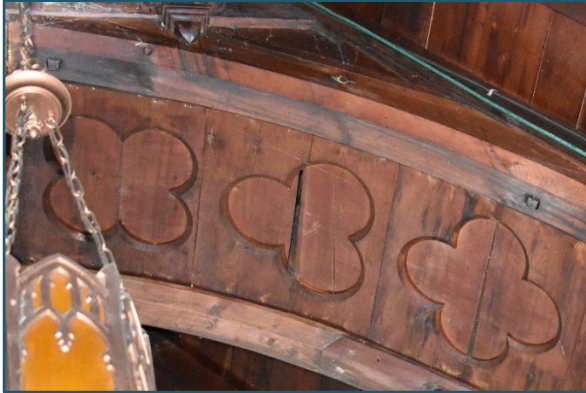
Figure 28: Cracks and triangular gaps in north arch panels.

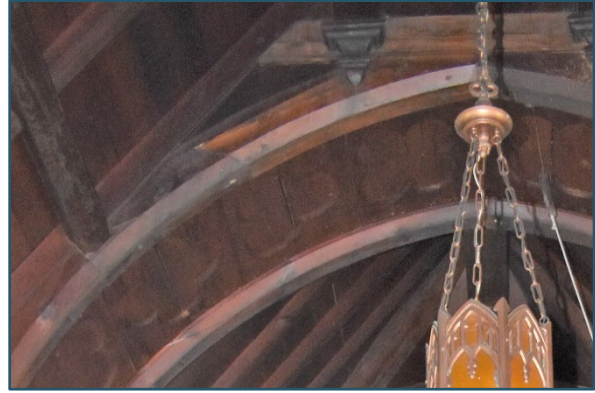
Figure 29: New cord near top of arch

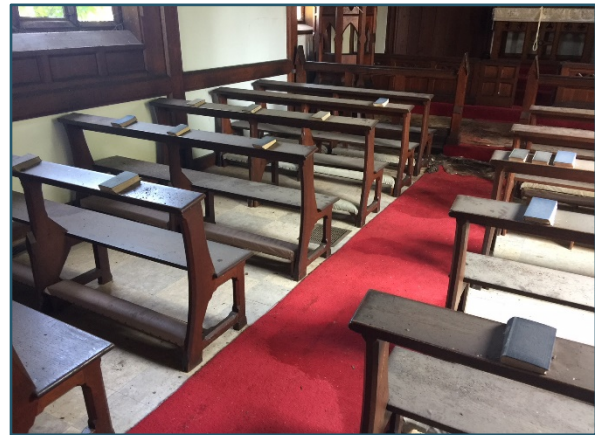
Figure 30: Raccoon feces near chancel porch, July 2018

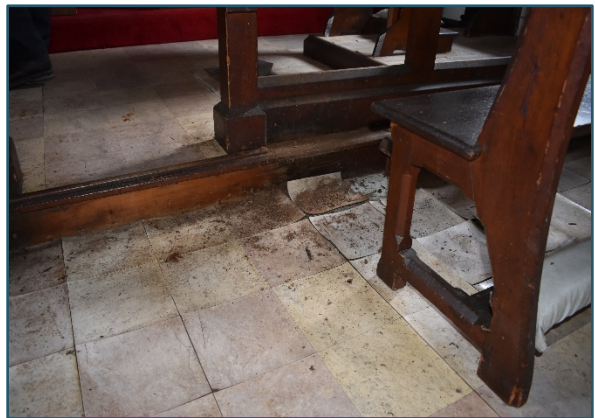
Figure 31: Warped tiles near chancel porch.

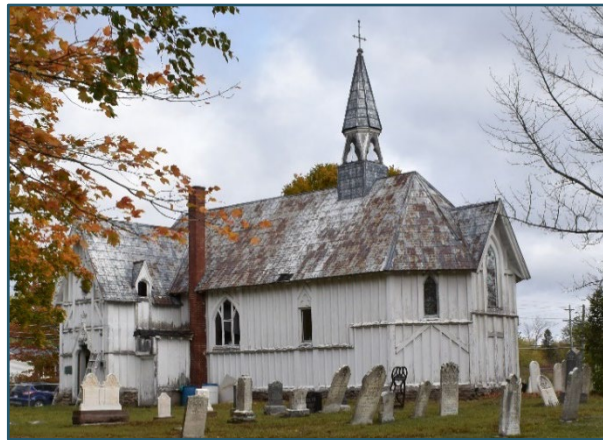
Figure 33: Southeast view, showing wood detailing around apse

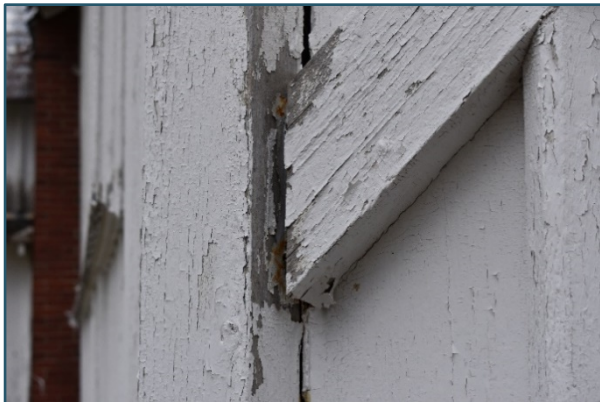
Figure 34: Separating joint at post

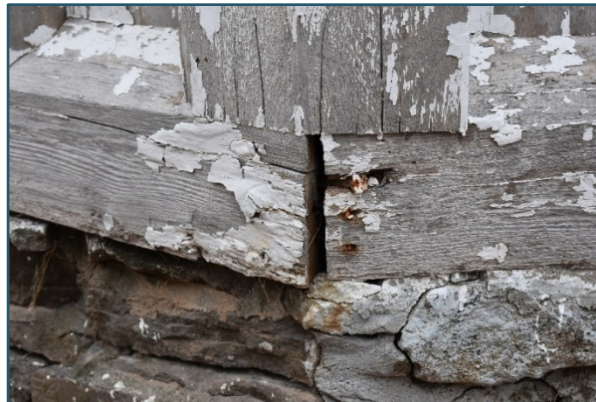
Figure 35: Separating at beam joint above foundation

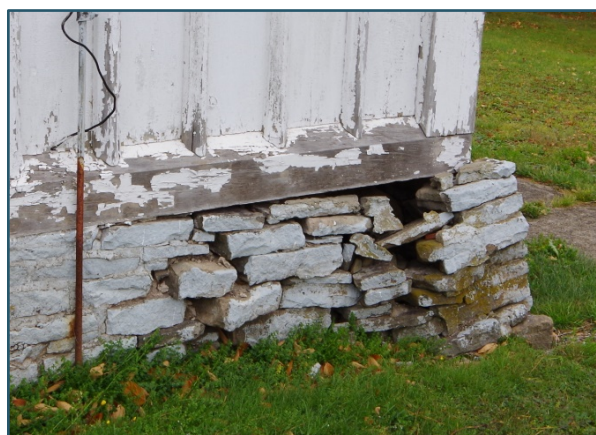
Figure 36: Southwest corner

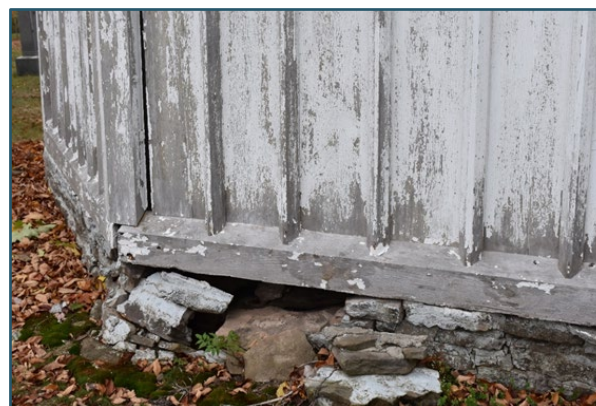
Figure 37: Gap at northeast corner

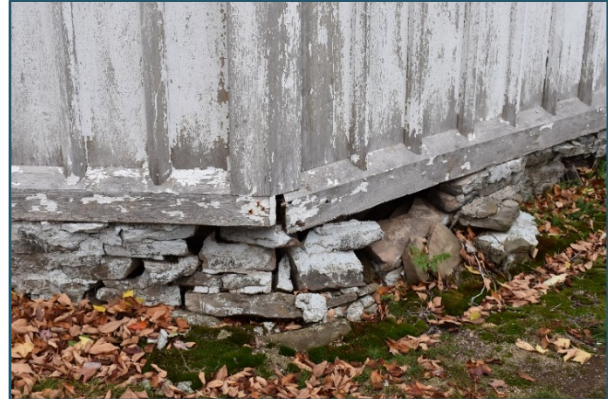
Figure 38: Cracked foundation and separated sill beams at northeast corner

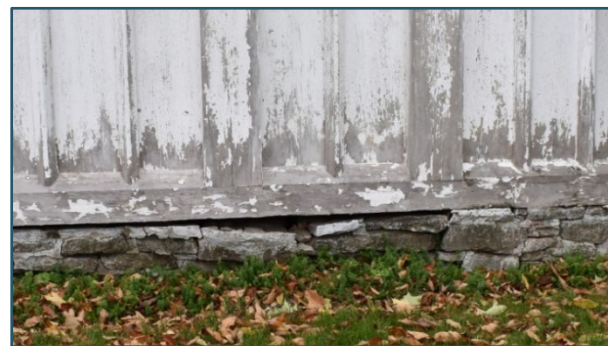
Figure 39: Failed foundation beneath chancel arch

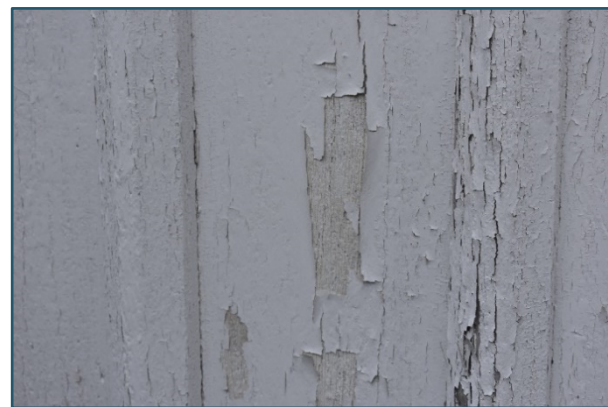
Figure 40: Layers of peeling paint

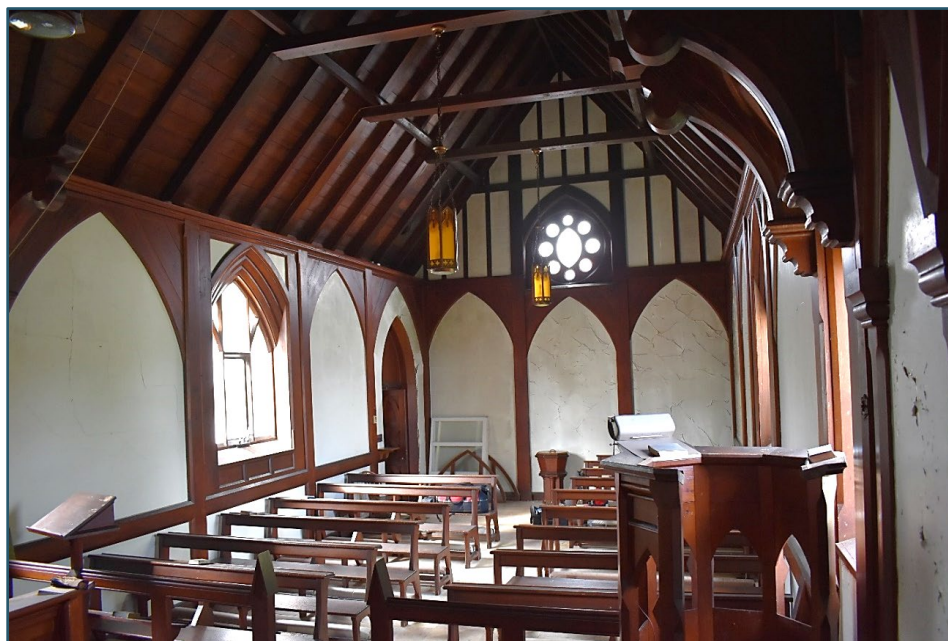
Figure 41: Church interior

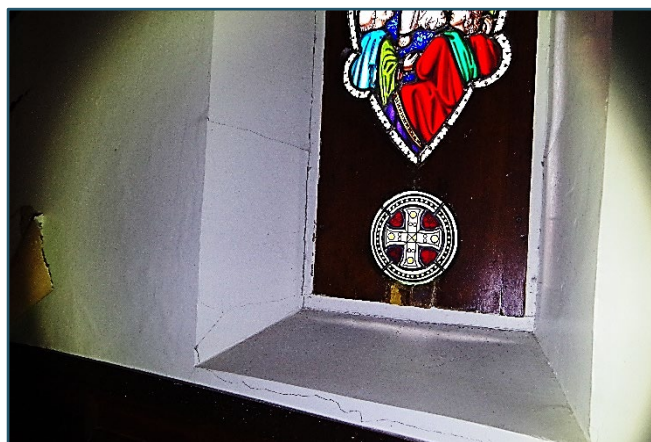
Figure 42: Cracking around stained glass

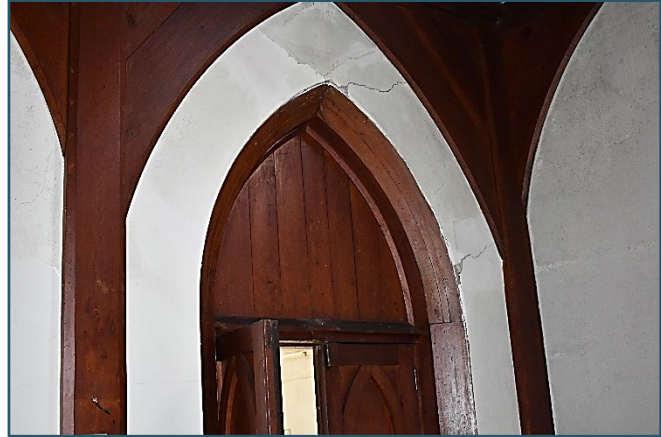
Figure 43: Crack above door arch

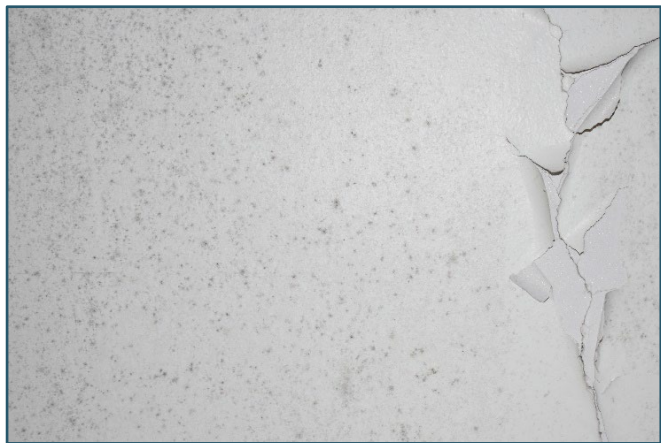
Figure 44: Mildew on west wall

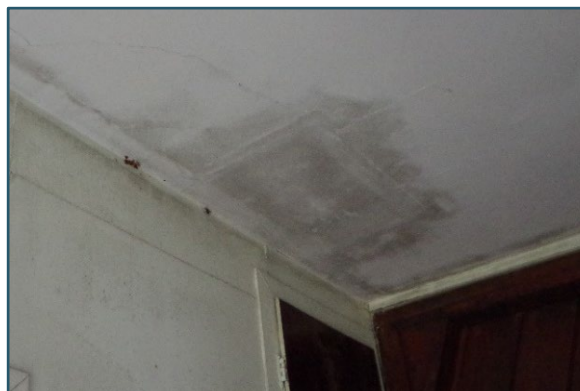
Figure 46: Previous chimney hole in narthex ceiling

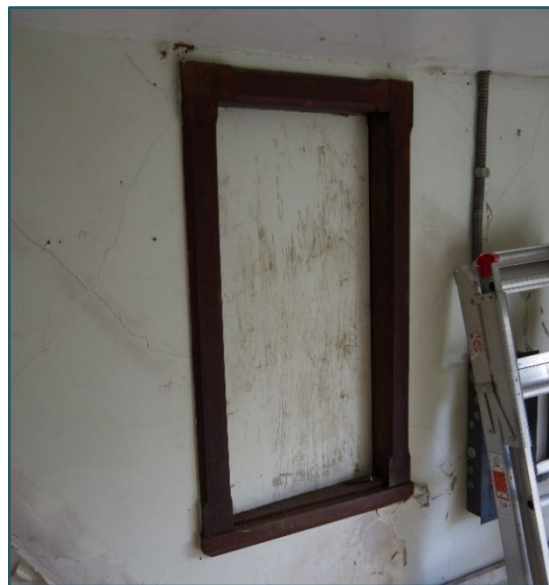
Figure 47: Boarded up narthex window

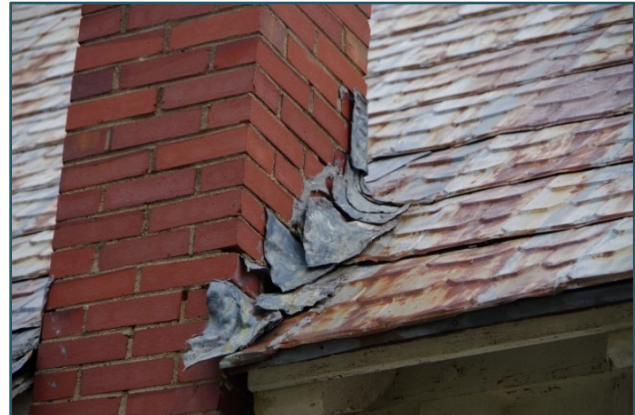
Figure 48: Failed chimney flashing

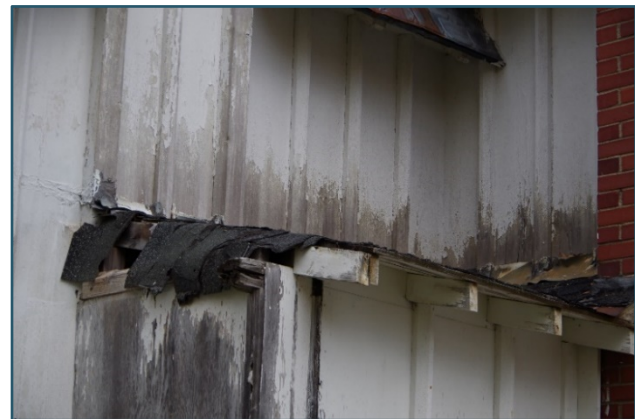
Figure 49: Deteriorated shed roof and water damage on wall

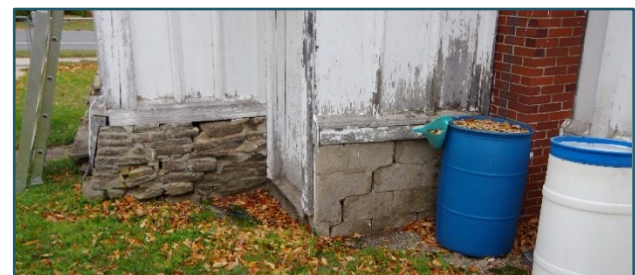
Figure 50: Cracked shed foundation

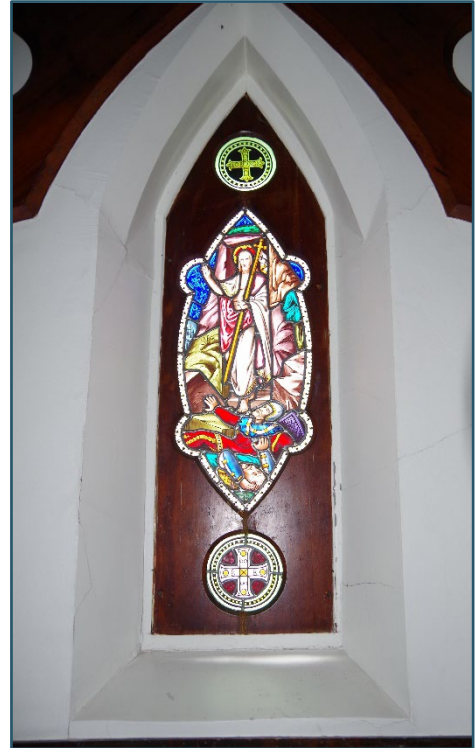
Figure 51: Stained glass window

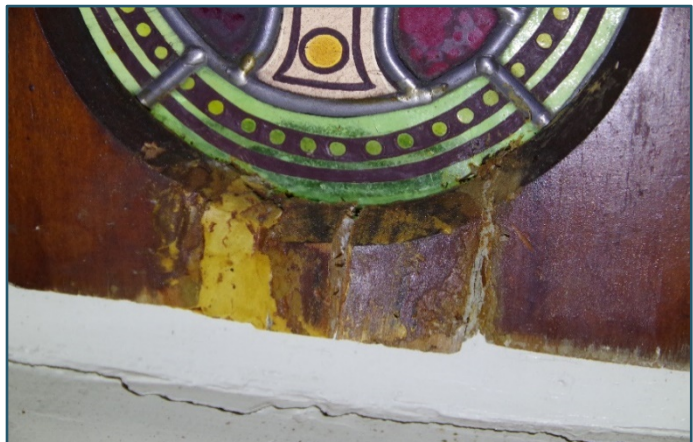
Figure 52: Cracked stained glass window frame
